Manhole Inspection Summary

Manhole # S33GG1004MH

Insp Date: **3/10/07 9:57 AM**

Location Address: **12 HADLEY SQ**

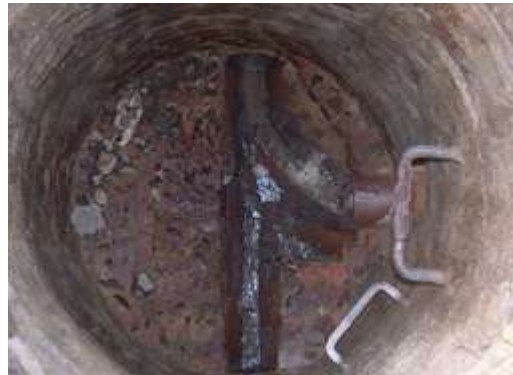
Top View

Corroded steps. Bench debris.

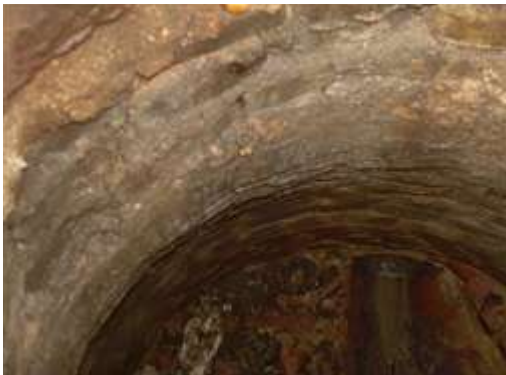
Defect

Frame leaks. Adjustment and Barrel infiltration.

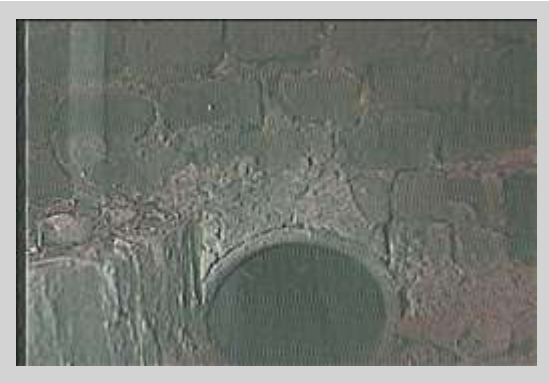
8 in. Circular Gravity Sewer Pipe Out @ 12 O'Clock

Barrel deterioration and infiltration. Channel deterioration.

Infiltration: **Evidence** Pipe Seal Cond: **Cracked**

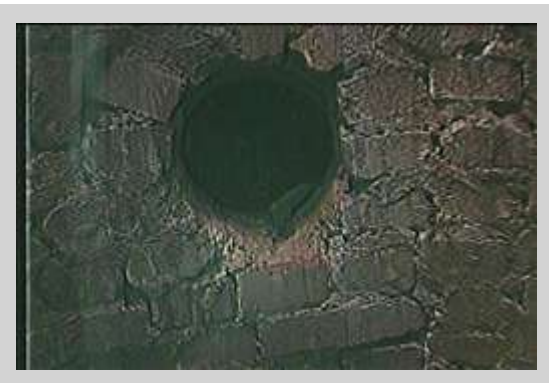
8 in. Circular Gravity Sewer Pipe In @ 3 O'Clock

Barrel deterioration and infiltration.

Infiltration: **Evidence** Pipe Seal Cond: **Broken**

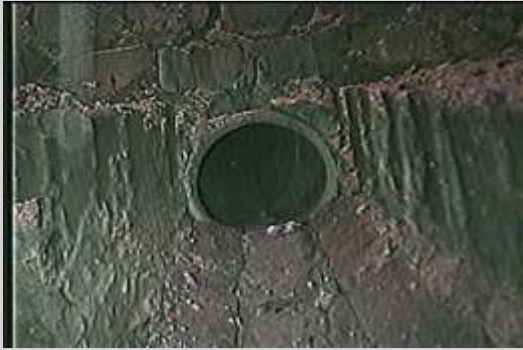
Pipe In @ 6 O'Clock

Barrel deterioration and infiltration. Channel deterioration.

Pipe Seal Cond: **Cracked**
